**INITIAL SUBDIVISION OF GENESIS EARLY SCIENCE POLISHED ALUMINUM COLLECTOR.** J. H. Allton<sup>1</sup>, E. K. Stansbery<sup>2</sup>, K. M. McNamara<sup>2</sup>, A. Meshik<sup>3</sup>, T. H. See<sup>1</sup>, R. Bastien<sup>1</sup>; <sup>1</sup>Lockheed Martin c/o NASA/Johnson Space Center, Mail Code KT, Houston, TX 77058; judith.h.allton@jsc.nasa.gov, <sup>2</sup>NASA/JSC, Mail Code KA, Houston, TX 77058, <sup>3</sup>Washington University, St. Louis, MO 63130.

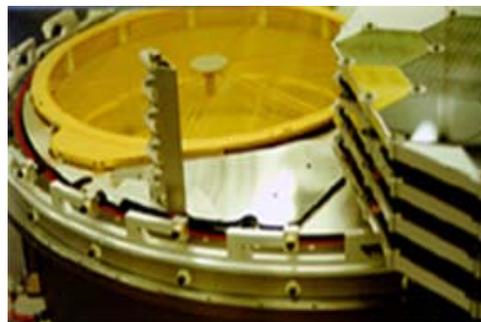
Fig. 1. Polished aluminum collector installed for flight.

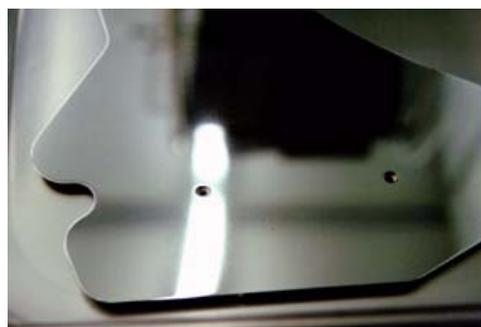
Fig. 2. Pre-flight close-up of polished surface.

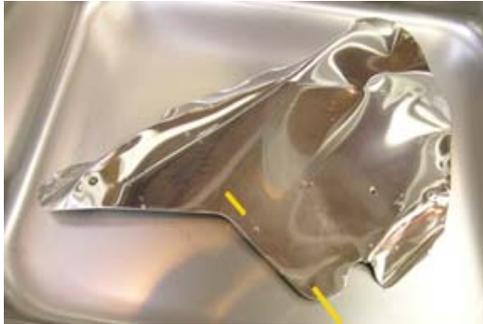
Fig. 3. Post-impact condition of polished aluminum collector. The yellow marks correlate with those on Fig. 5.

**Introduction:** A large surface, about 245 cm<sup>2</sup>, of highly polished aluminum 6061 T6 alloy was attached to the science canister thermal panel for the purpose of collecting solar wind noble gases. The analysis of this collector will be part of the Genesis Early Science results. The pre-launch configuration of the collector is shown in Figs. 1 & 2. The collector sustained some damage during the recovery impact in Utah, September 8, 2004 (Fig. 3; for details of recovery operations see [1]).

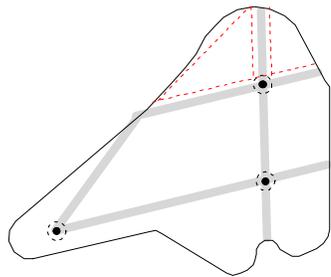
Fig. 4. Ribs on back side are traced in gray to show location. Saw cuts are mapped in red. Width of collector in this view is 23 cm.

**Collector Composition and Pre-Flight Handling:** The polished aluminum collector was milled from 0.2-inch-thick Al 6061 T6 stock, such that most of the surface was 0.025-inch thick, supported by 0.1-inch thick ribs (Fig.4). Polishing this surface was challenging, and as a result several iterations of polishing occurred, beginning with Al<sub>2</sub>O<sub>3</sub> and ending with diamond paste. Remnant pieces were polished in a similar manner and archived. The polished collector was then rinsed in hexane, soaked in hexane 20 minutes and further rinsed with hexane and isopropanol. Rinsings were archived. Final cleaning was done with ultrapure water using a megasonic wand. Rinse water contained <100 ppb TOC and <5 particles of >1µm diameter. Final cleaning and installation of collector into science canister was done in Class 10 cleanroom.

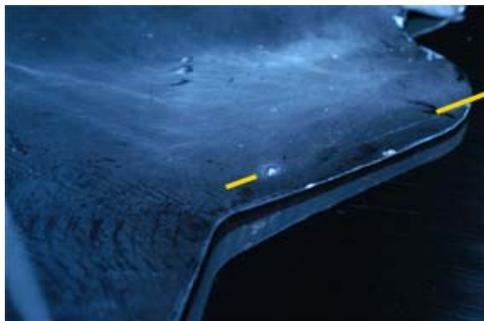
*Post-flight collector surface observations.* Oblique lighting revealed dust or coating patterns on the polished surface (Fig. 5). Mud spatters and smears, often ringed with evaporate deposits, were also observed. Other than nitrogen gas dust-off, no cleaning was performed. The portion of the collector to be removed and sent to Meshik was scanned to map the location of impact craters >40 µm. In this portion of the collector, comprising about 45 cm<sup>2</sup>, 13 features were noted of which 8 were identified as craters ranging in size from 40 to 300 µm. Crater diameters were measured at 40, 62, 62, 62, 108, 163, 170 and 300 µm. We plan to scan the entire surface.

Fig. 5. Oblique lighting reveals dust or coatings on surface. Bright spot near center is mud/salt spatter. Between yellow lines a boundary mark exists corresponding to shadowing or impact imprint of saddle thermal shield.

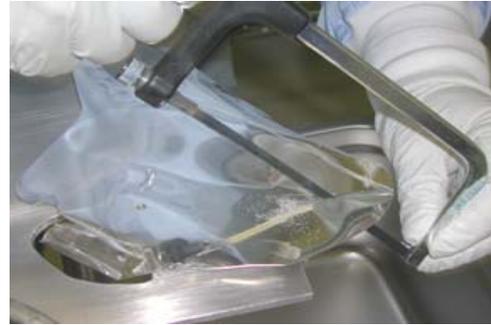
Fig. 6. Polished aluminum collector (it appears a hazy light blue because it reflects the blue cleanroom smock) secured to custom plate being hand- sawed.

**Subdivision of the Collector:** The collector was secured to the table top on a plate carved-out to allow bent portions of the collector to be recessed. The collector was mounted using the fittings formerly used to install the collector onto the spacecraft. Saw cuts were made adjacent to ribs to minimize flexing of the thin sheet. Using a small handsaw, to minimize contamination and heating (Fig. 6), the collector was subdivided into 5 parts: parent 50684 and subsamples 50684.1, 50684.2, 50684.4, 50684.5 (Fig. 7). Subsample 5 was

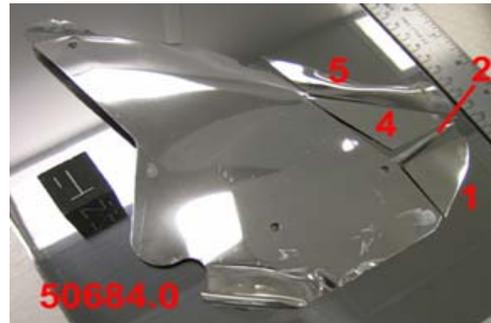
Fig. 7. Group view of pieces after subdivision.

removed to separate a muddy smudge and severely curled surface from cleaner, flatter specimens. Sub-sample 1 and 4 are fairly flat and subsample 2 is a rib. Fig. 8 shows a close-up of quality of surface on 50684.4, including an evaporite deposit. The largest piece remains in nitrogen storage at JSC, awaiting continued scanning for micrometeorites.

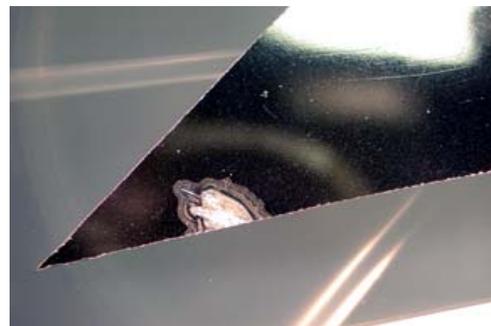
Fig. 8. Close-up of cut piece 50684.4 showing good quality surface, evaporite deposit (5 mm) and 2 cut edges.
